**SITUATION ASSESSMENT REPORT (SAR) AS
PART OF THE ESTUARY MANAGEMENT PLAN
FOR St LUCIA ESTUARY WITHIN
ISIMANGALISO WETLAND PARK**

**COMPILED IN TERMS OF THE NATIONAL ESTUARINE MANAGEMENT
PROTOCOL (2021) & THE NATIONAL ENVIRONMENTAL MANAGEMENT:
INTERGRATED COASTAL MANAGEMENT ACT (ICMA, ACT 24 OF 2008)**

SAR-Scoping phase

09 December 2022

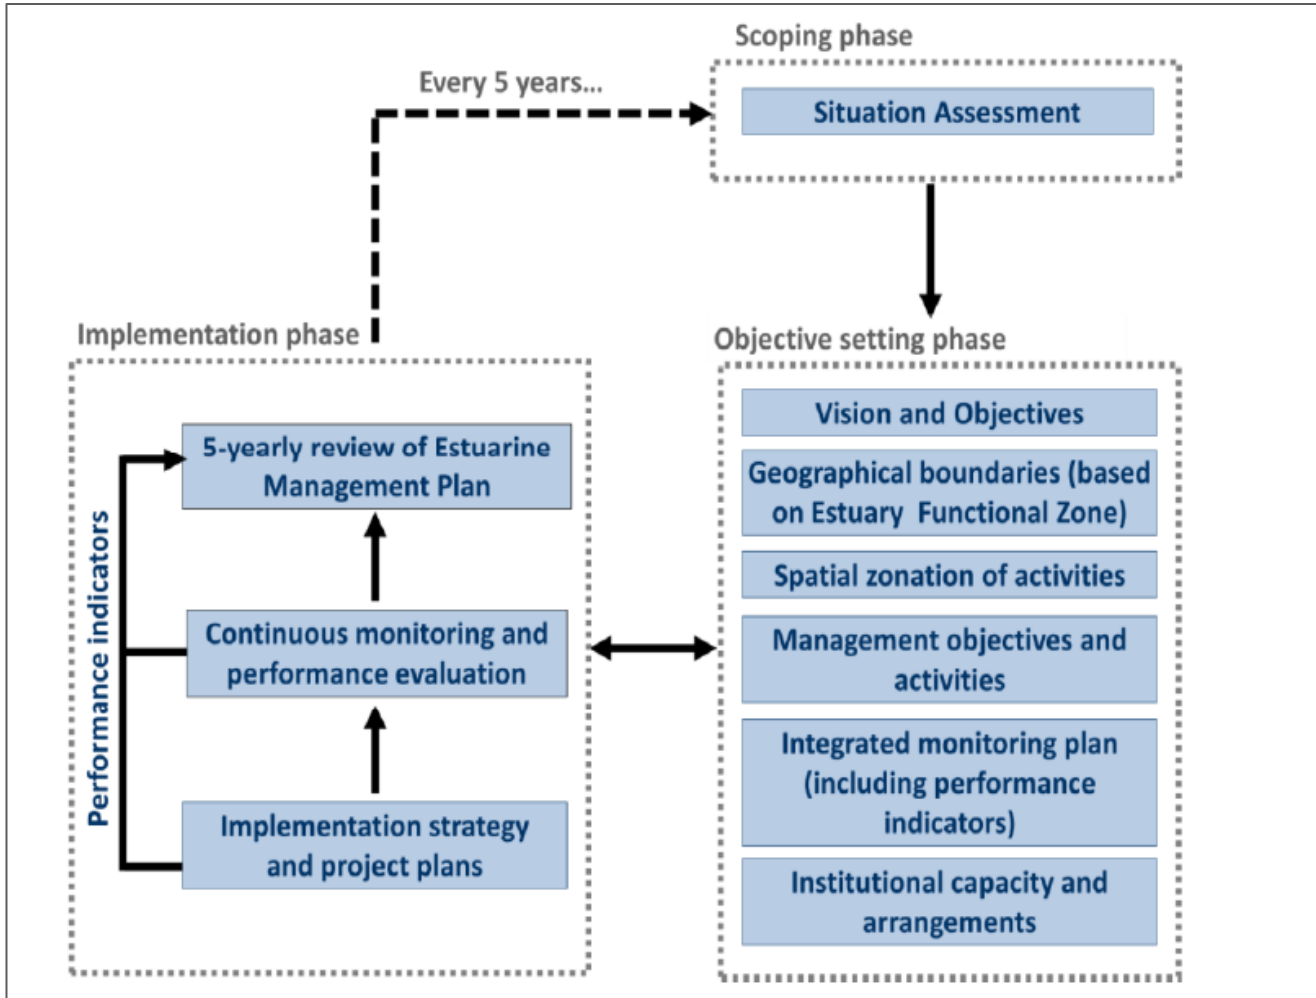
Figure 3: Framework for Estuarine Management Plan

The development of an EstMP is a three-phase process. As illustrated in Figure 3 below comprising an initial scoping phase, followed by an objective setting phase, and finally an implementation phase. An adaptive management approach should be adopted during the latter phase with detailed reviews being conducted at five-yearly intervals

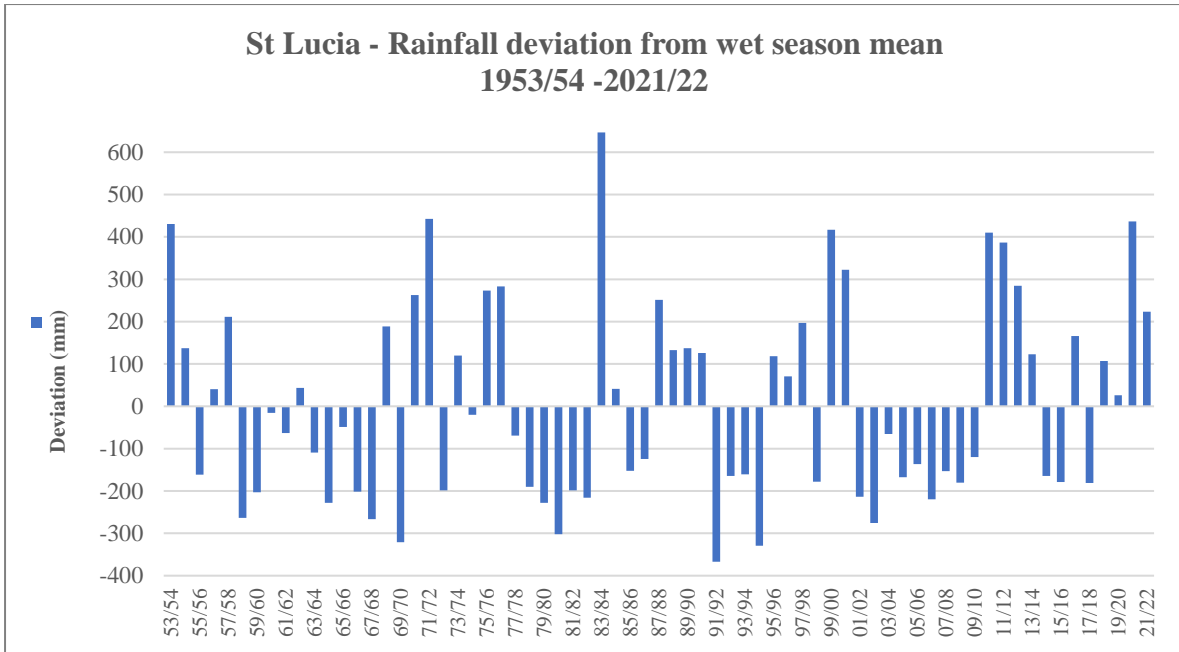
Figure 6: Rainfall deviation from the wet season mean (0 mm) recorded at St Lucia (EKZNW) main office since 1953/54 (Fox & Mfeka, 2022a).

Note that this graph was produced prior to the April-May 2022 flood events (refer Fig. B), therefore the updated 2022 figure will increase.

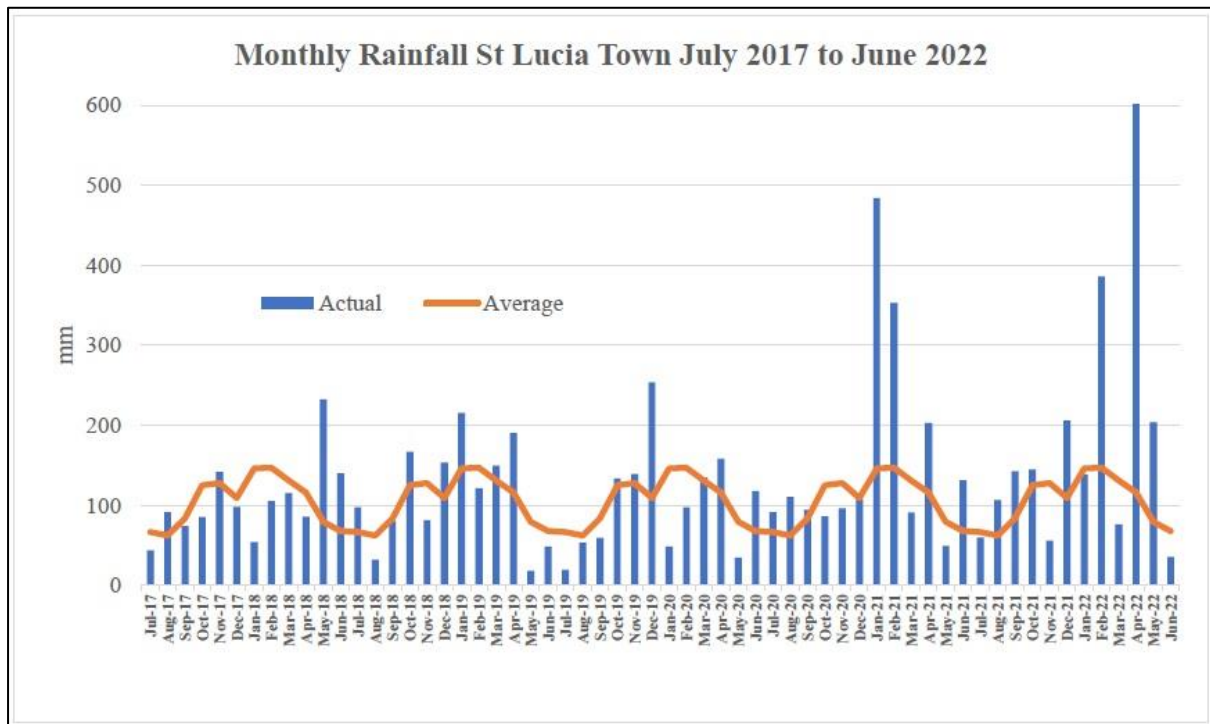
Figure 7: Total monthly rainfall measured at the St Lucia EKZNW main office (S28.382733 E32.412099) for the past five years together with the long term average rainfall (since 1971) (Fox & Mfeka, 2022b).

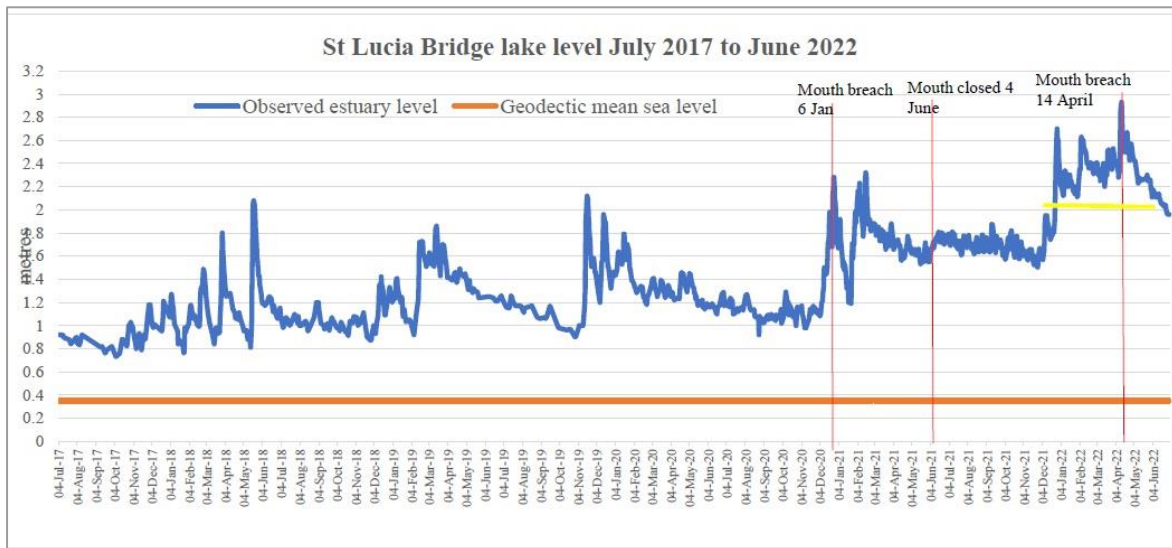
Figure 9: Water levels at the St Lucia Bridge (S28.369954, E32.409939) over the past five years. (The data is not calibrated to mean sea level). The yellow line indicates that the level has been above 2 m since late Dec 2021

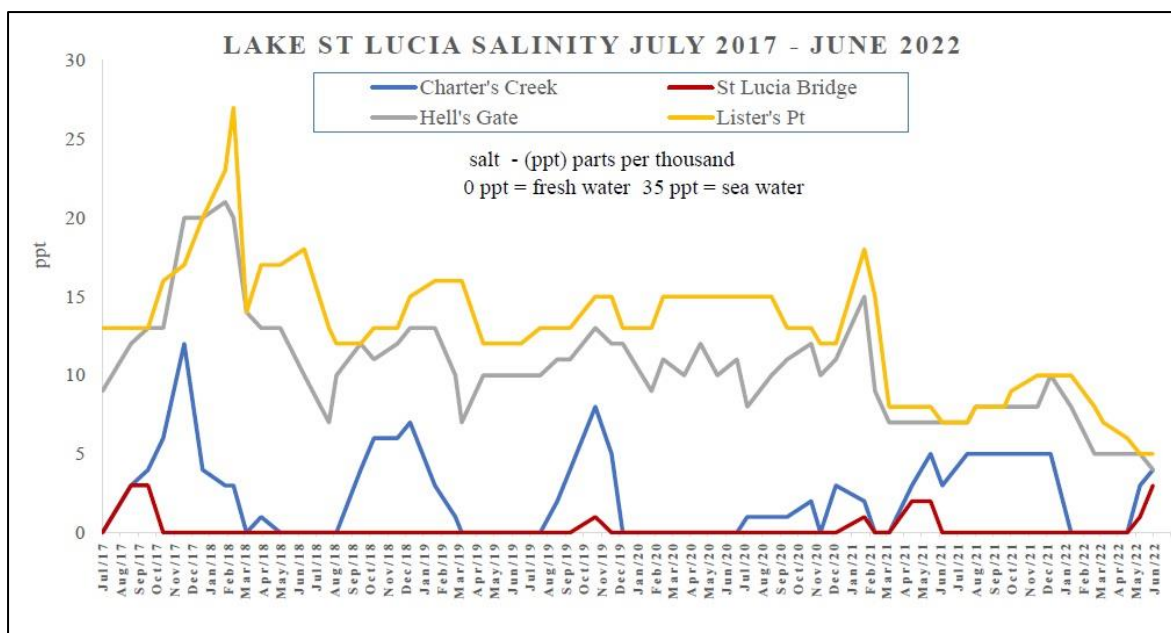
Figure 10: Track of salinity concentrations over the past five years for North Lake (Lister's Point & Hell's Gate), South Lake (Charter's Creek) and the Narrows (St Lucia Bridge).

Figure 10 below illustrates the salinity measured during the past five years. A 'reversed' salinity pattern is evident, where the northern parts of the lake were more saline than the southern area. This higher salinity in the north is largely due to the residual salt in the system after the drought conditions of a few years ago. After the mouth breached in mid-April 2022, seawater was able to penetrate only to a small degree into the St Lucia Bay and lower portions of the Narrows. The southern half of Lake St Lucia has effectively been a freshwater lake for the past four years (Fox & Mfeka, 2022b).

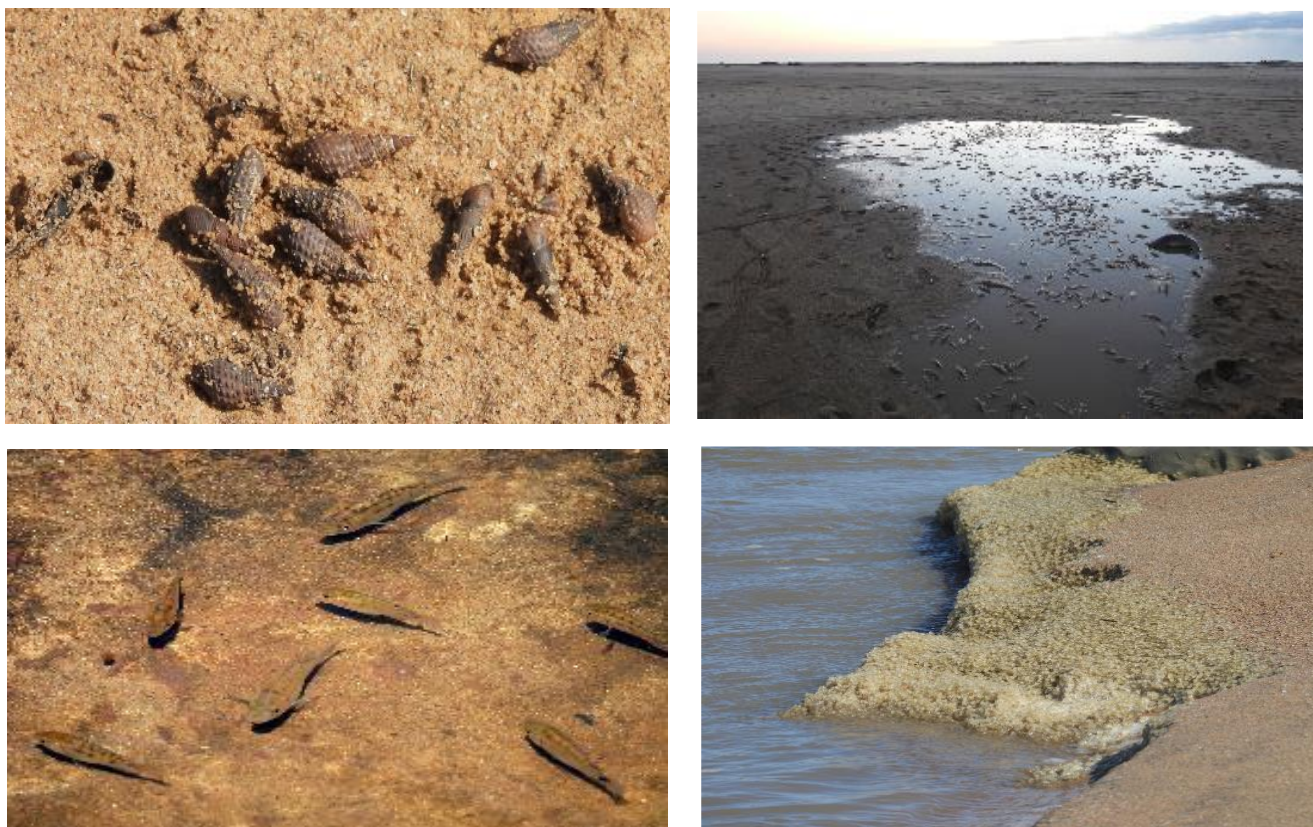
Figure 12: Alien *Tarebia granifera* snails stranded by the sinking water levels in the lake. Indigenous snails interspersed within image, b) Stranded *Macrobrachium equidens*, c) *Veruna litterata* along the edges of the estuary mouth, d) freshwater *Tilapia* within the estuary. All images adapted from Fox, C & Mfeka, S. (2022) Current physical & biological conditions of Lake St Lucia & the Mfolozi/Msunduzi Estuary, Jan to Mar 2022 and Fox, C & Mfeka, S. (2022) Current physical & biological conditions of Lake St Lucia & the Mfolozi/Msunduzi Estuary, April to June 2022

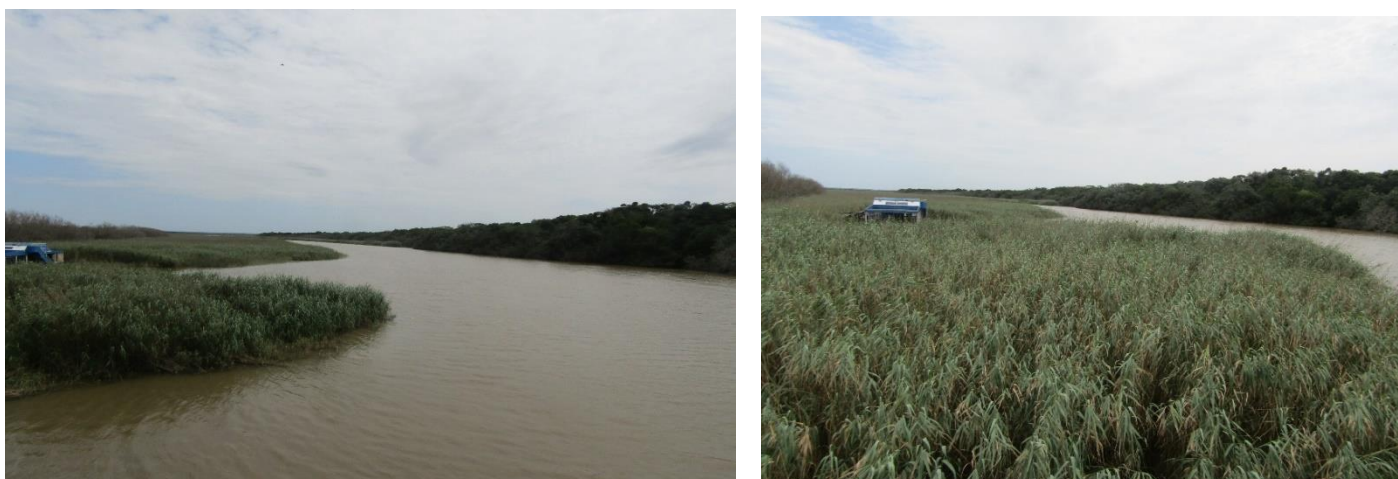
Figure 13: two images showing darker water from Mfolozi to Msunduzi
